**CORROSION CONDITION SURVEY  
OF U1020 MONTANA AVENUE OVERPASS-BILLINGS  
FOR  
MONTANA DEPARTMENT OF TRANSPORTATION  
WJE No. 2000.2547  
November 27, 2000**

CORROSION CONDITION SURVEY  
OF U1020 MONTANA AVENUE OVERPASS-BILLINGS  
FOR  
MONTANA DEPARTMENT OF TRANSPORTATION  
WJE No. 2000.2547  
November 27, 2000

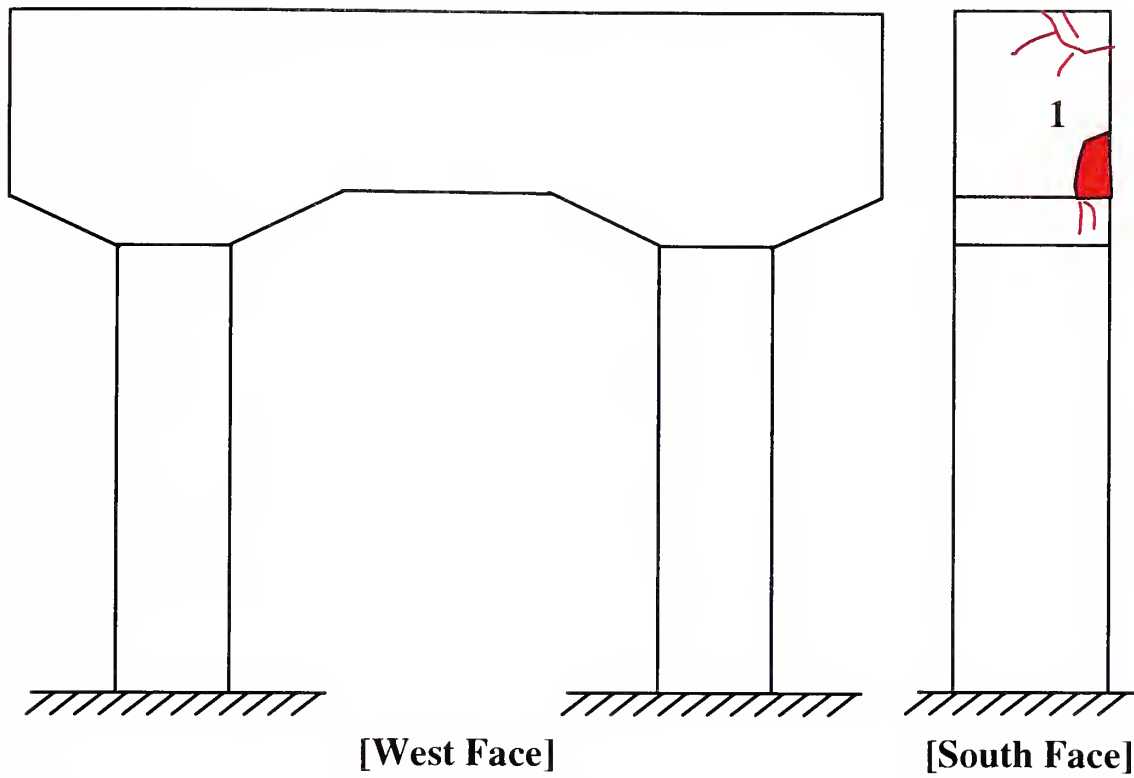
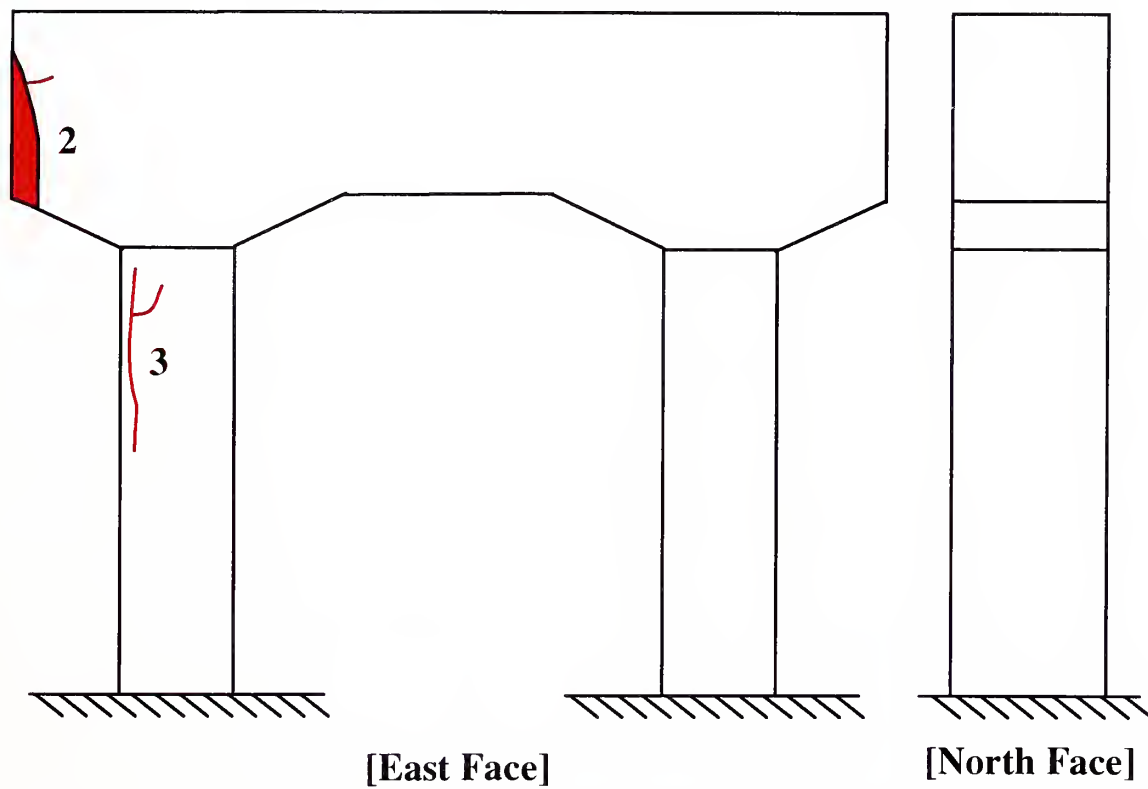
Figure 27A. Condition of Bent No. 28 (East Bound).

Damage	Location	Face	Description of Damage (No.)	Leakage Condition: No leakage but damp below beams 2-5  Test Performed: None
	S. Col.	South	Small spall and six cracks (1)	
	Cap	East	Small spall and a crack (2)	
	S. Col.	North	Two cracks (3)

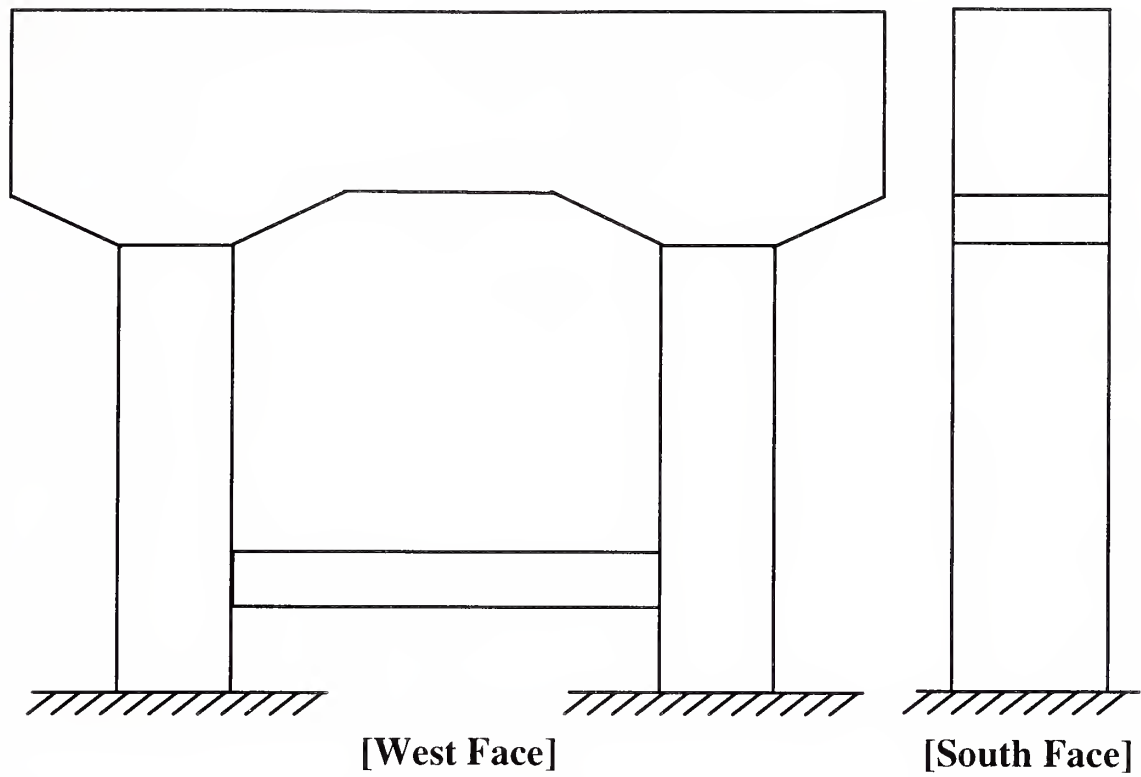
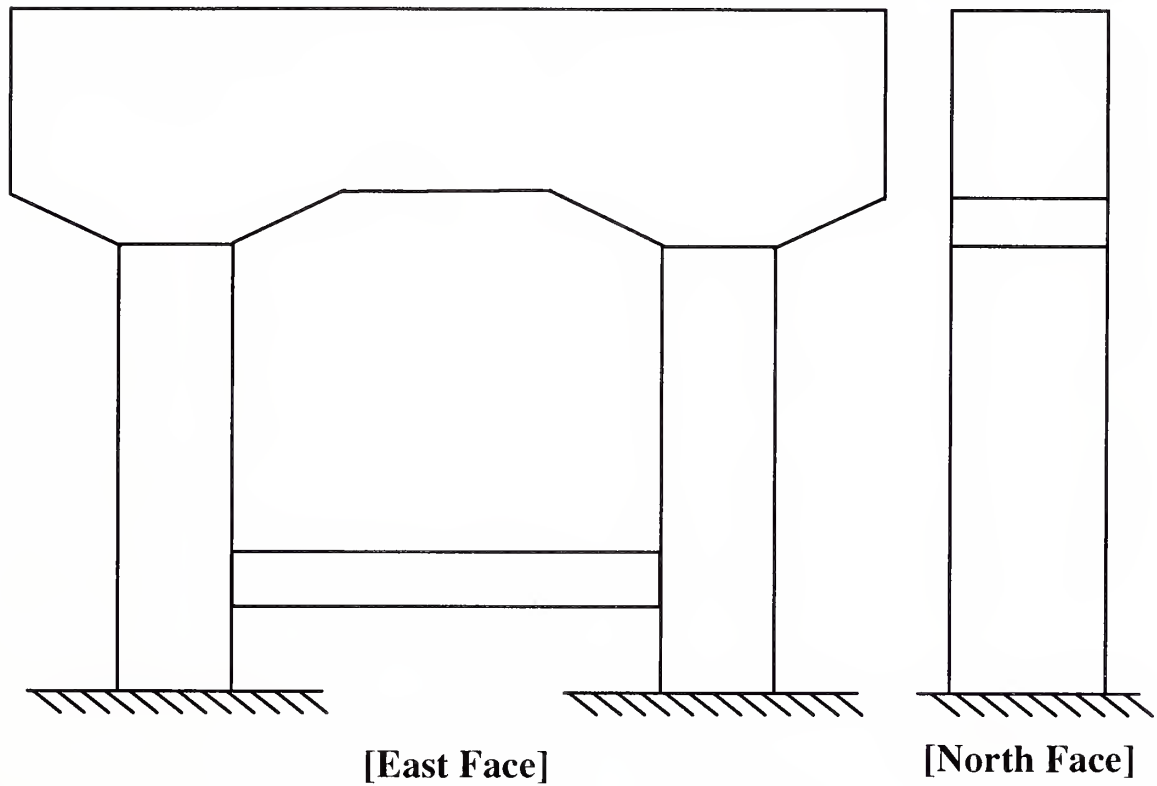
Figure 28A. Condition of Bent No. 29 (East Bound).

Damage	Location	Face	Description of Damage (No.)	Leakage Condition: No Leakage
		<b>No Damage Observed</b>		Test Performed: None

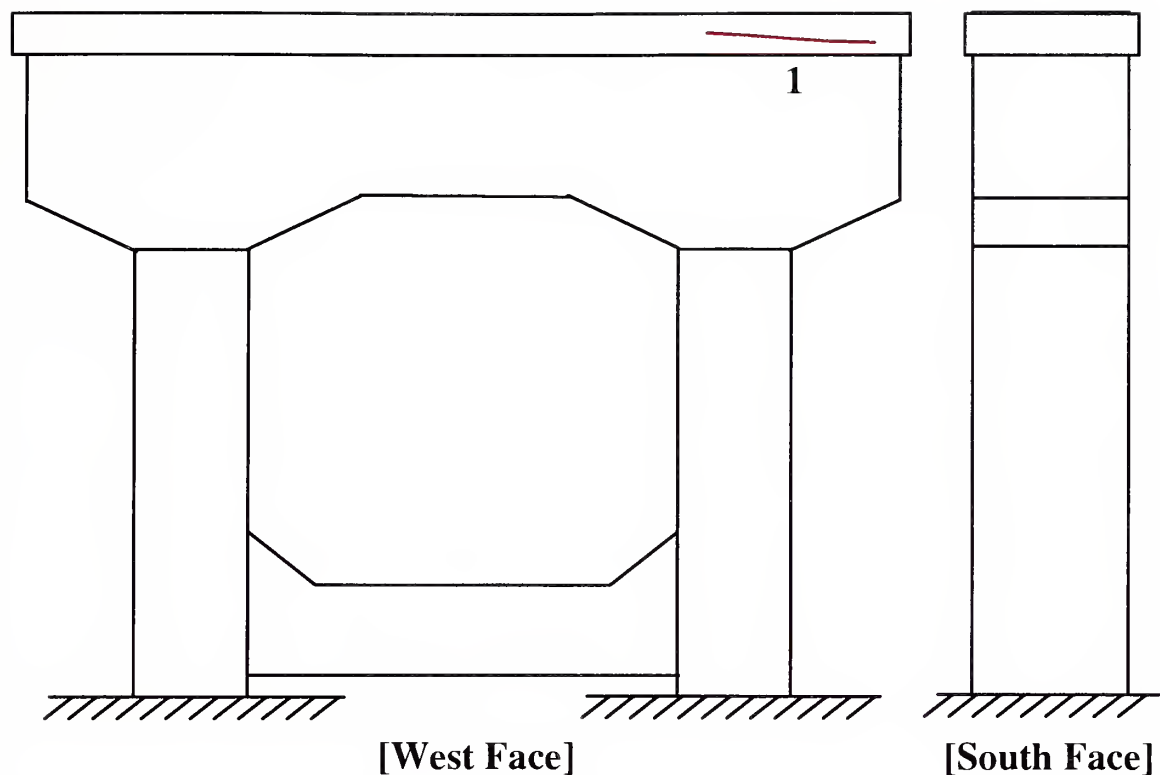
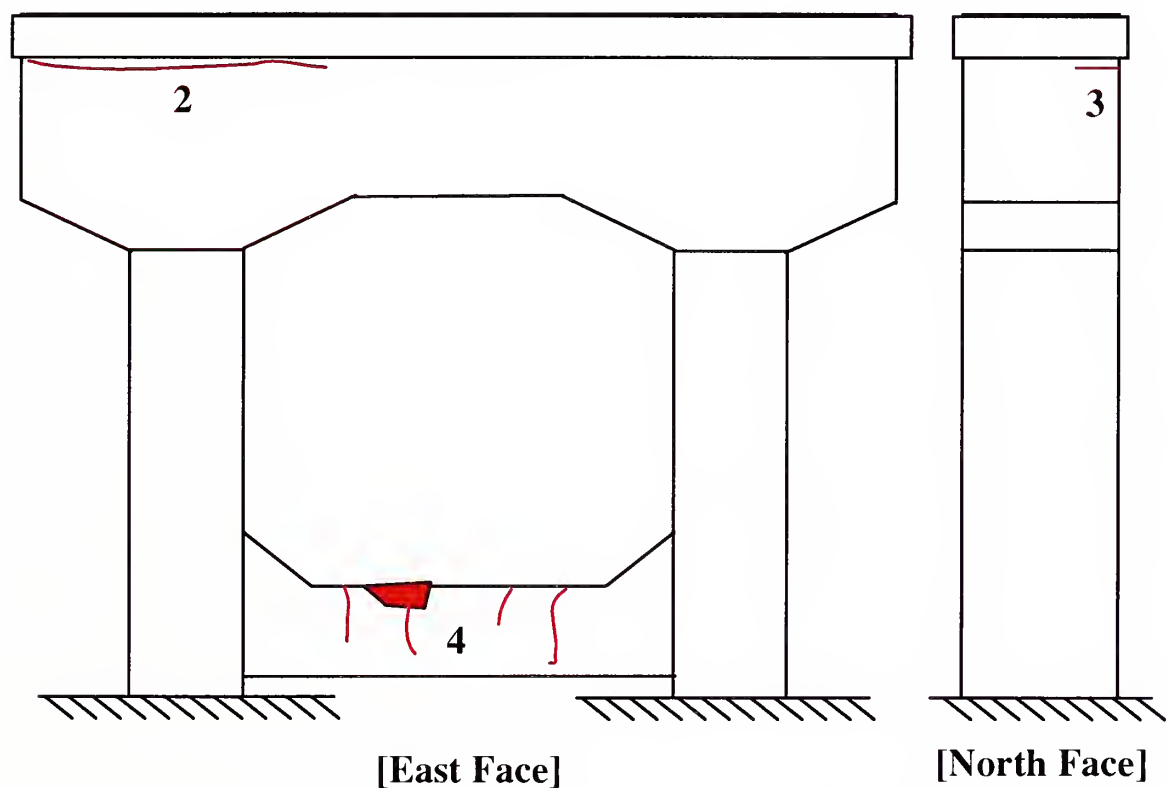
Figure 29A. Condition of Bent No. 30 (East Bound).

Damage	Location	Face	Description of Damage (No.)	Leakage Condition: Active leakage below beams 1-5  Test Performed: None
	Cap	West	A crack with stain (1)	
	Cap	East	A crack (2)	
	Cap	East	A crack (3)	
	Beam	East	A spall and four cracks (4)

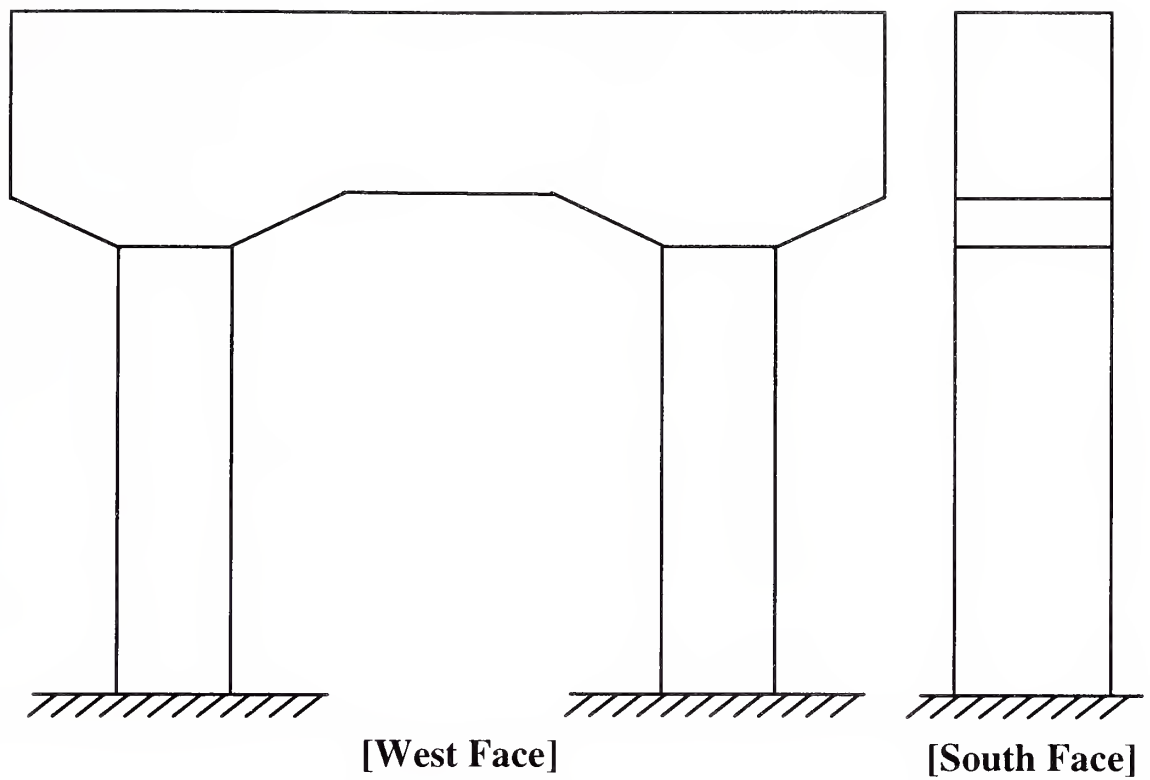
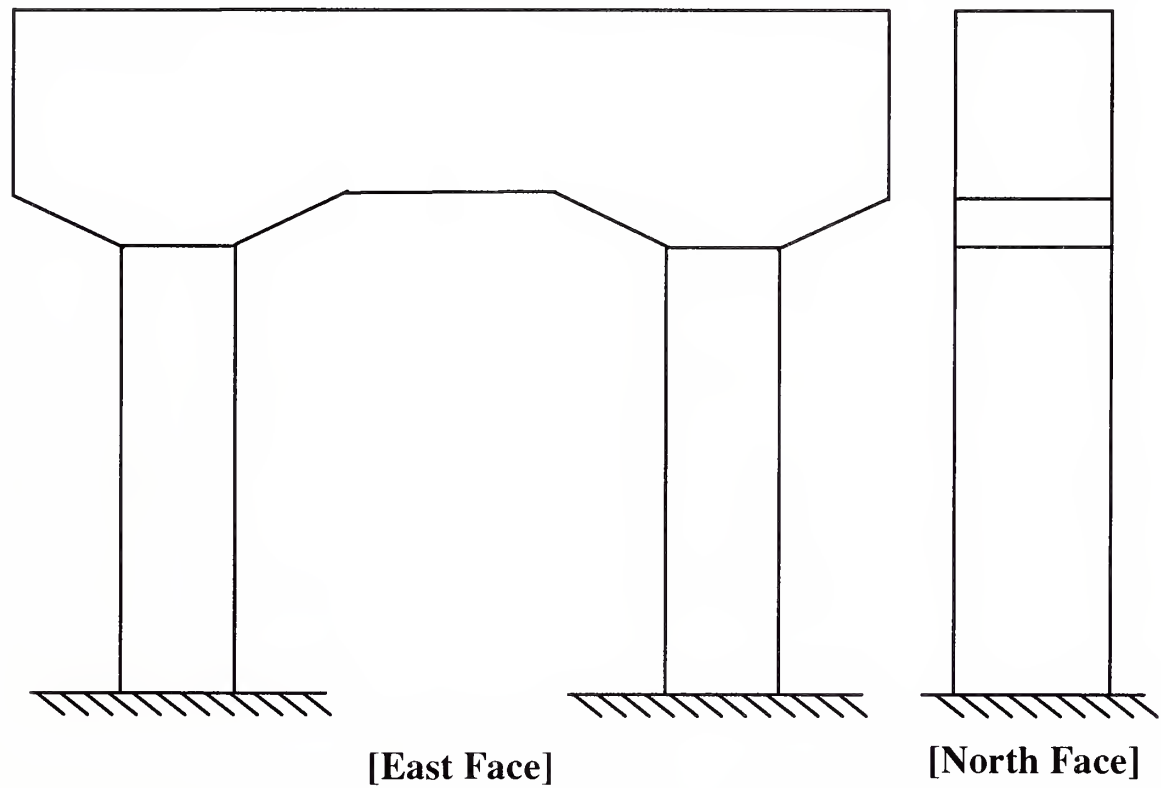
Figure 30A. Condition of Bent No. 31 (East Bound).

Damage	Location	Face	Description of Damage (No.)	Leakage Condition: Active leakage below beams 1-5  Test Performed: None
			<b>No Damage Observed</b>

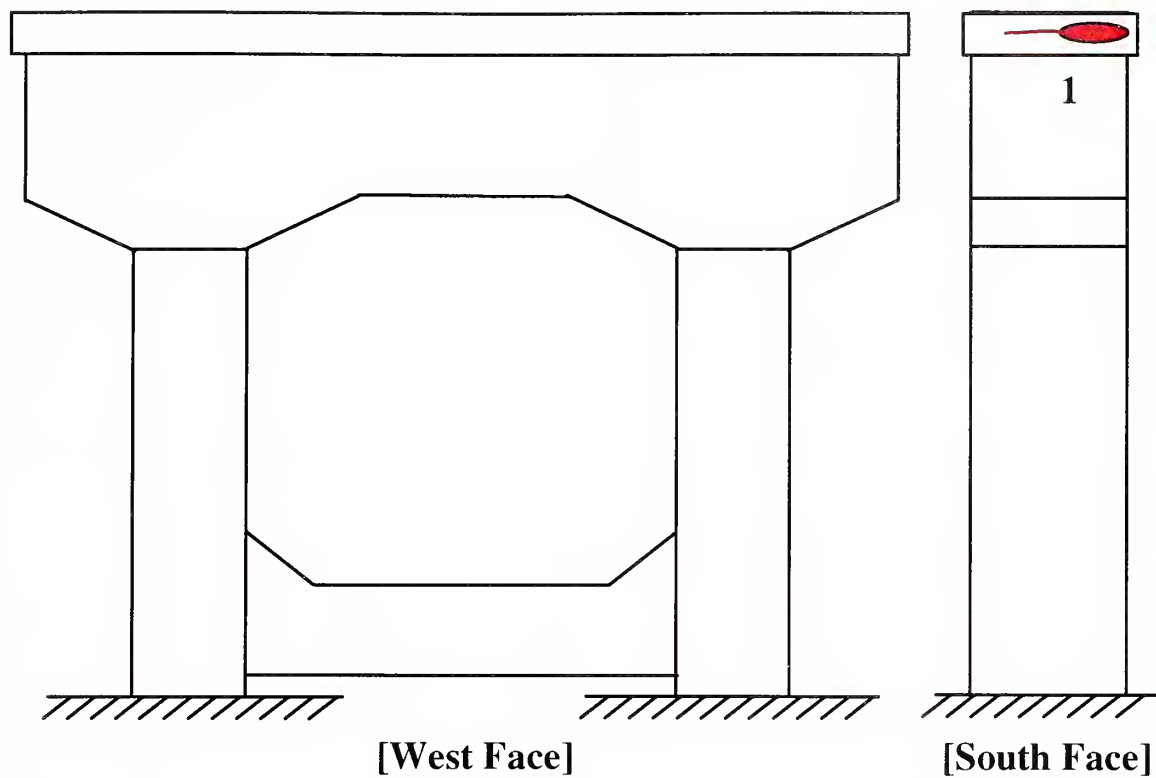
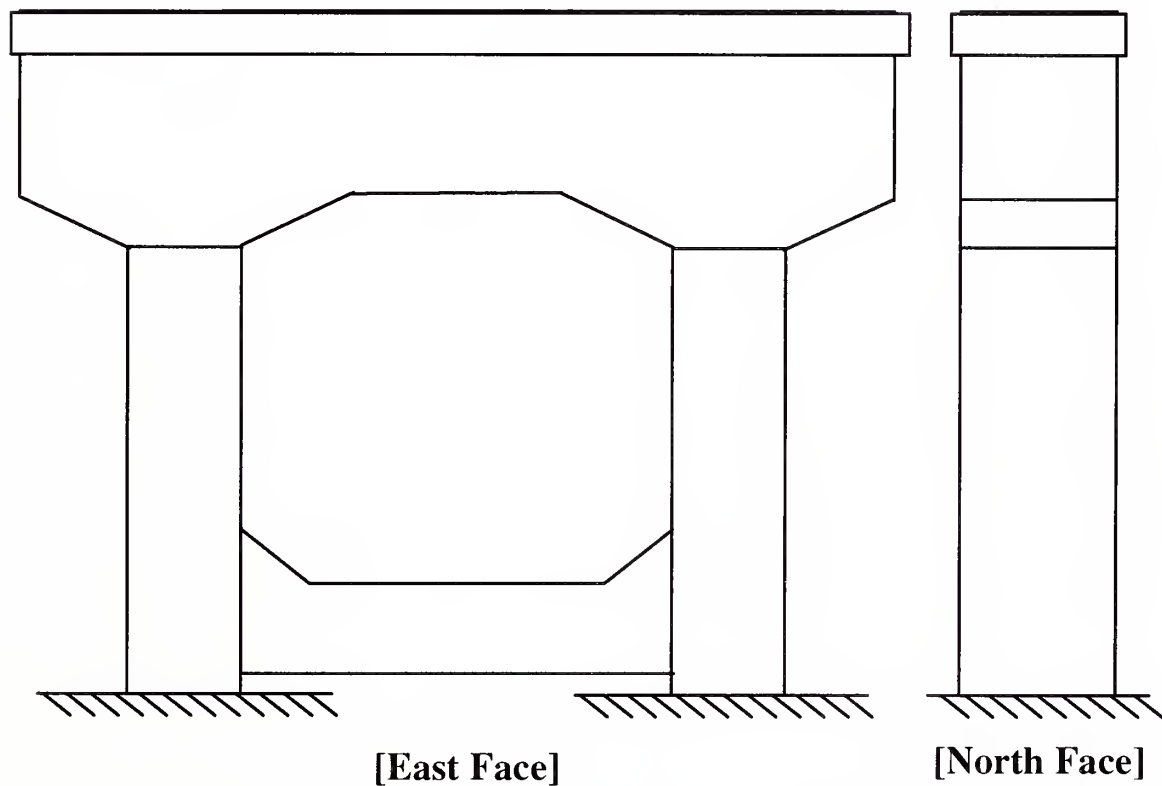
**Figure 31A. Condition of Bent No. 32 (East Bound).**

Damage	Location	Face	Description of Damage (No.)	Leakage Condition: No leakage but moist
	Cap	South	A spall and a crack (1)	
				Test Performed: None

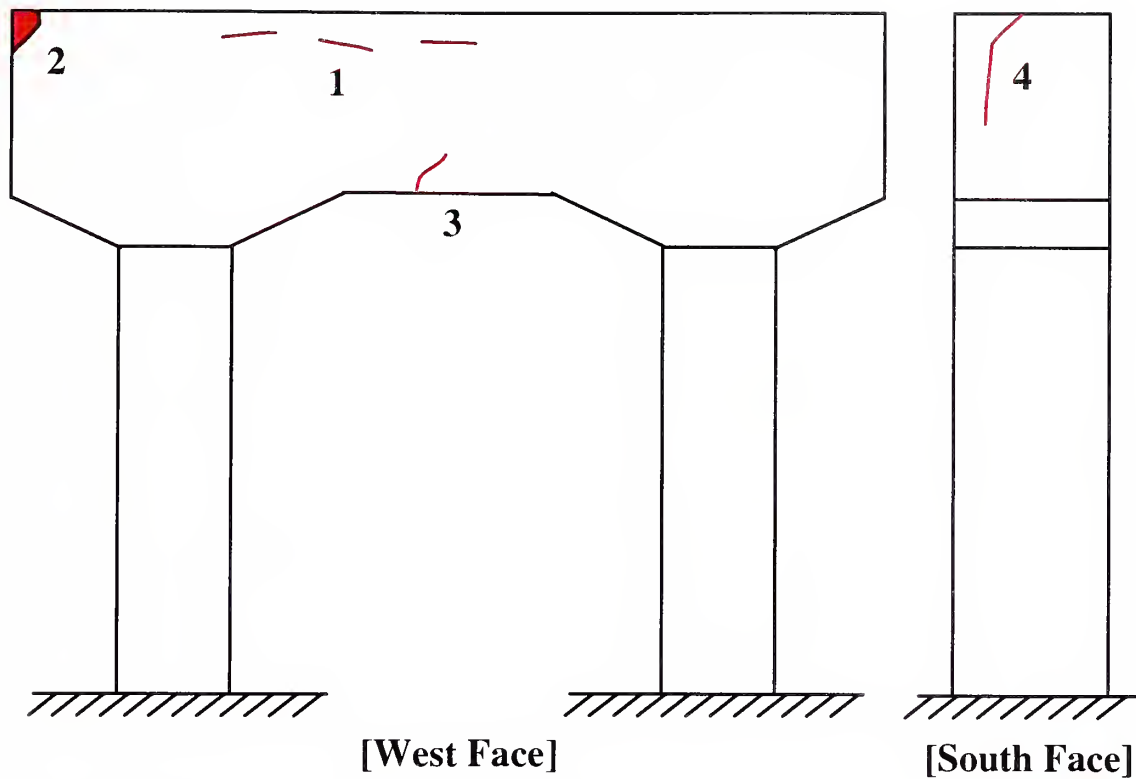
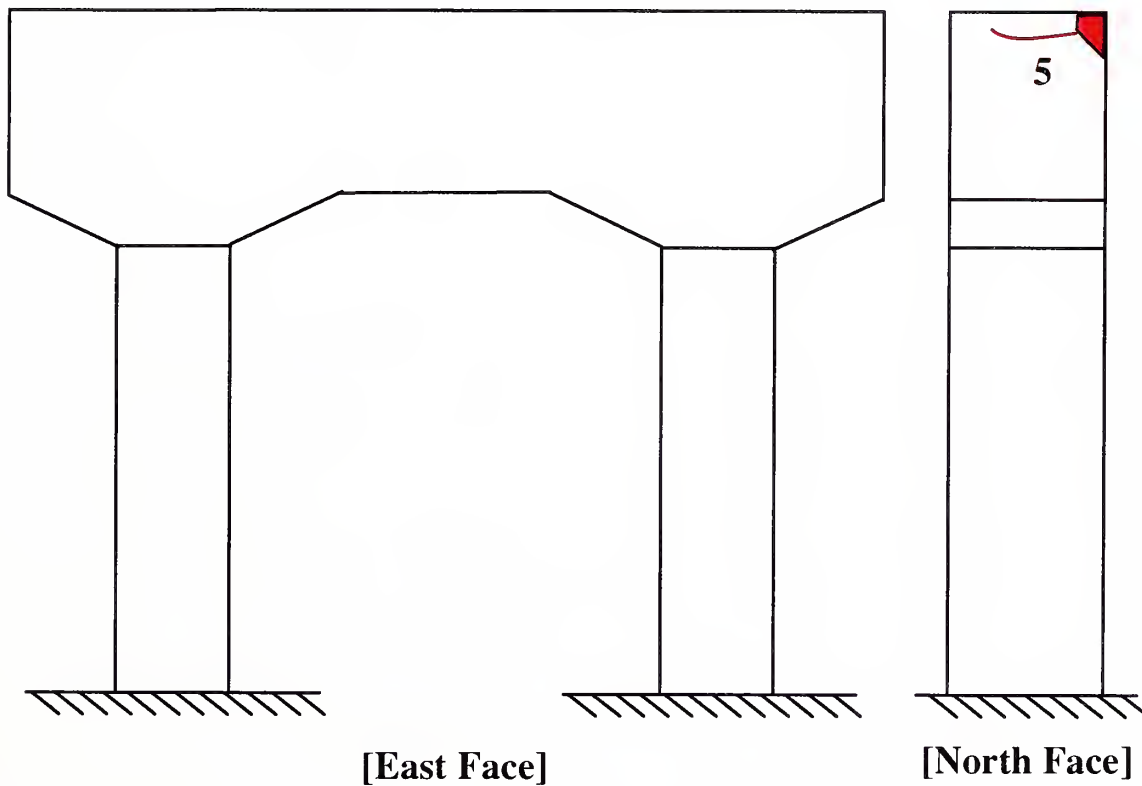
**Figure 33A. Condition of Bent No. 3 (West Bound).**

Damage	Location	Face	Description of Damage (No.)	Leakage Condition: Active leakage in center and joint moist south end Test Performed: None
	Cap	West	Three small cracks (1)	
	Cap	West	Small spall (2)	
	Cap	West	A crack extended to underside(3)	
	Cap	South	A crack (4)	
	Cap	North	Small spall and a crack (5)

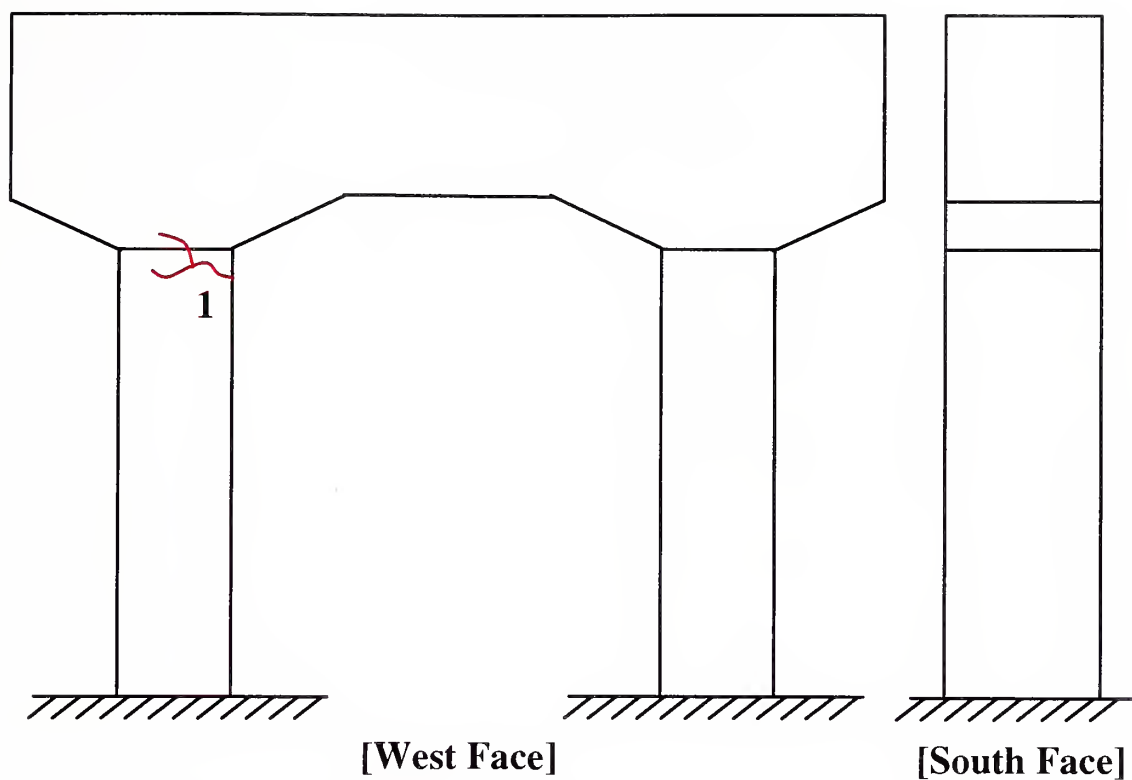
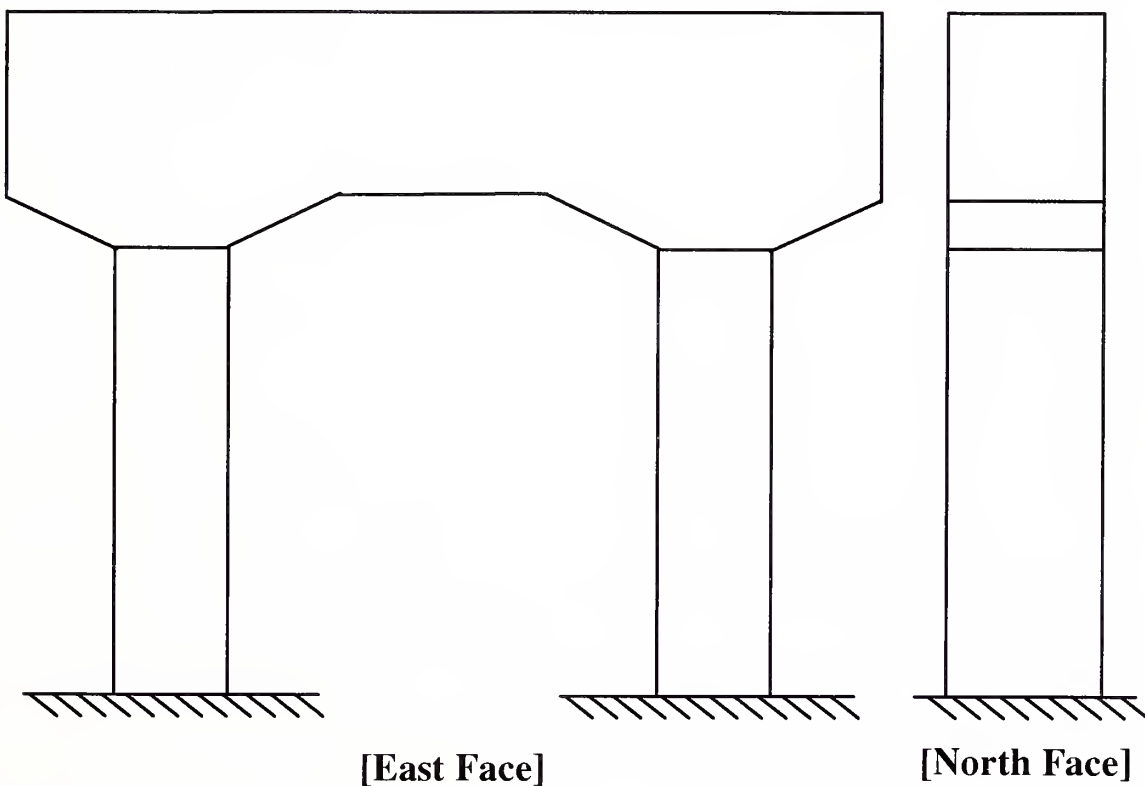
**Figure 34A. Condition of Bent No. 4 (West Bound).**

Damage	Location	Face	Description of Damage (No.)	Leakage Condition: No Leakage
	N. Col.	West	Two cracks (1)	
				Test Performed: None

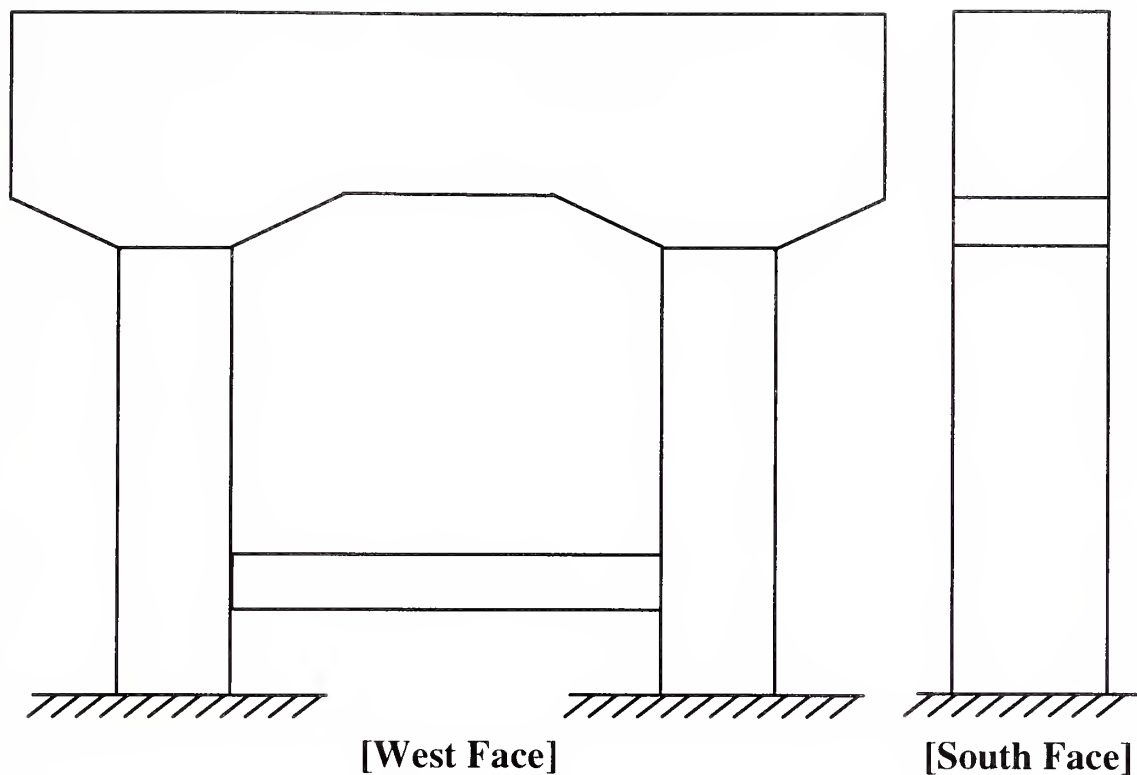
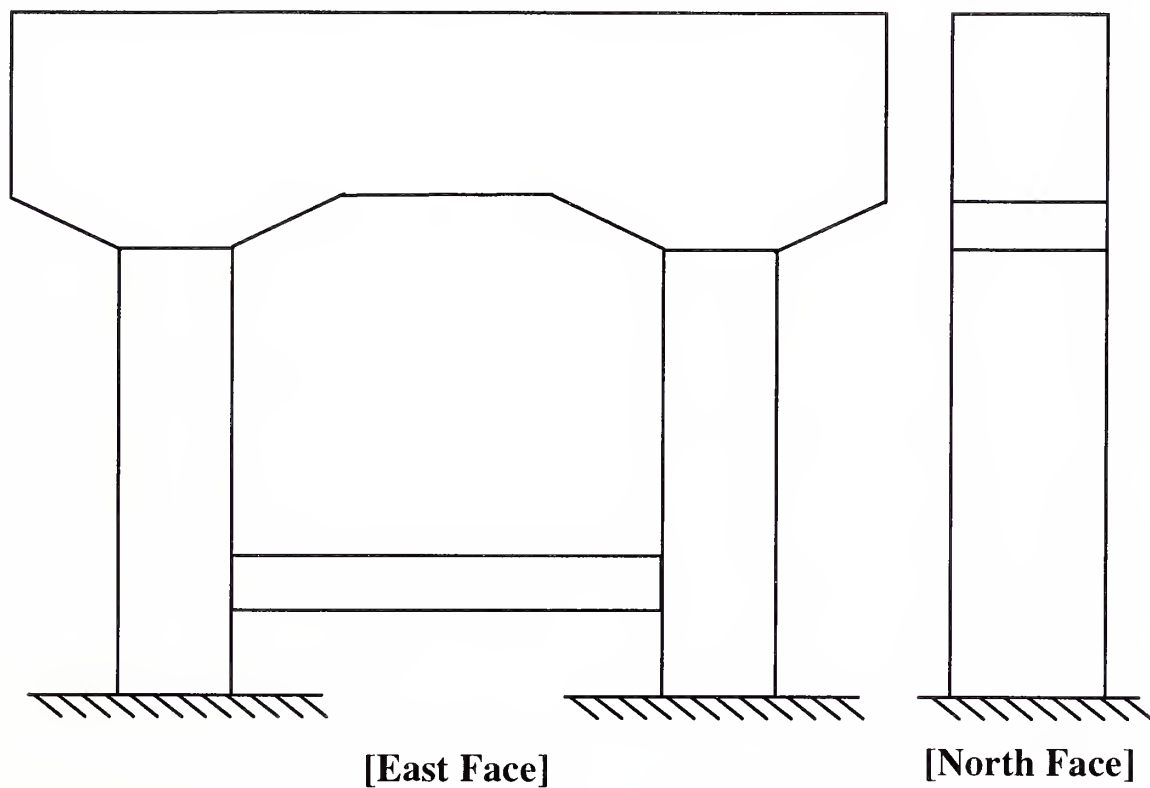
Figure 36A. Condition of Bent No. 6 (West Bound).

Damage	Location	Face	Description of Damage (No.)	Leakage Condition: No Leakage
				Test Performed: None
		<b>No Damage Observed</b>

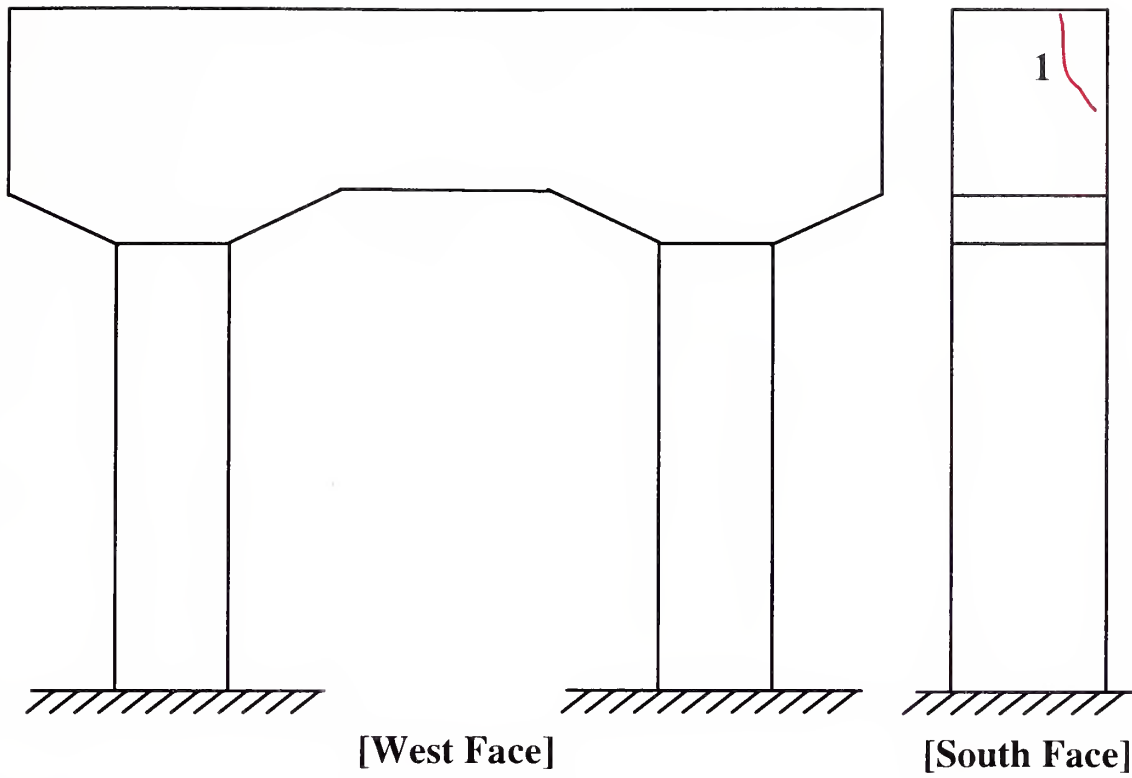
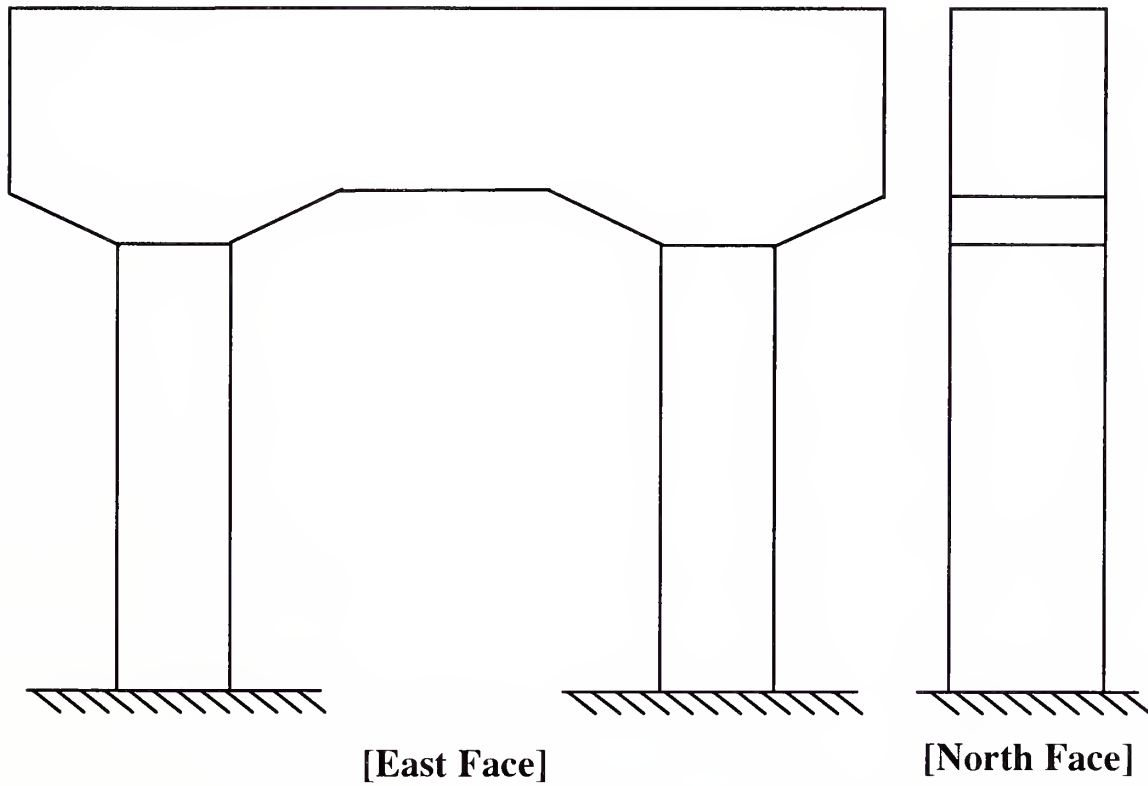
Figure 37A. Condition of Bent No. 7 (West Bound).

Damage	Location	Face	Description of Damage (No.)	Leakage Condition: No Leakage
	Cap	South	A crack (1)	
				Test Performed: None

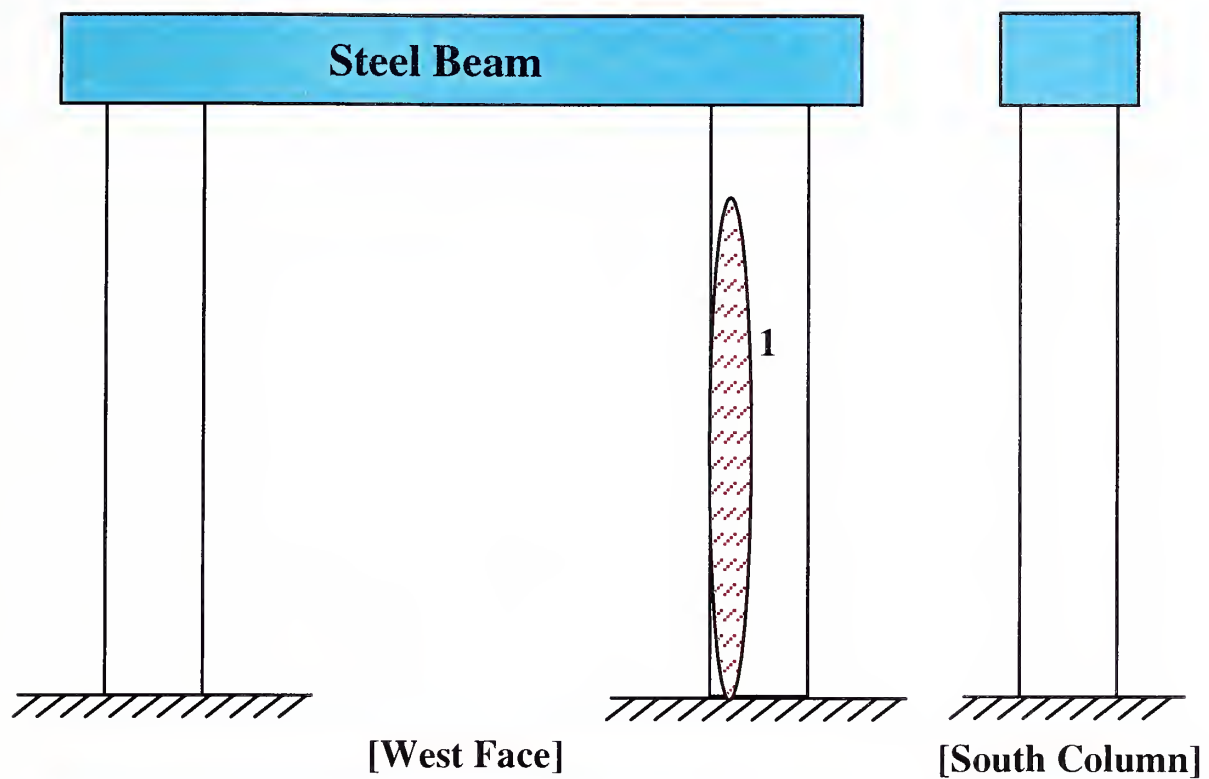
Figure 39A. Condition of Bent No. 9 (West Bound).

Damage	Location	Face	Description of Damage (No.)	Leakage Condition: No deck above and exposed  Test Performed: None
	Column	Circular	Multiple cracks on NW and W sides (1): Photo taken

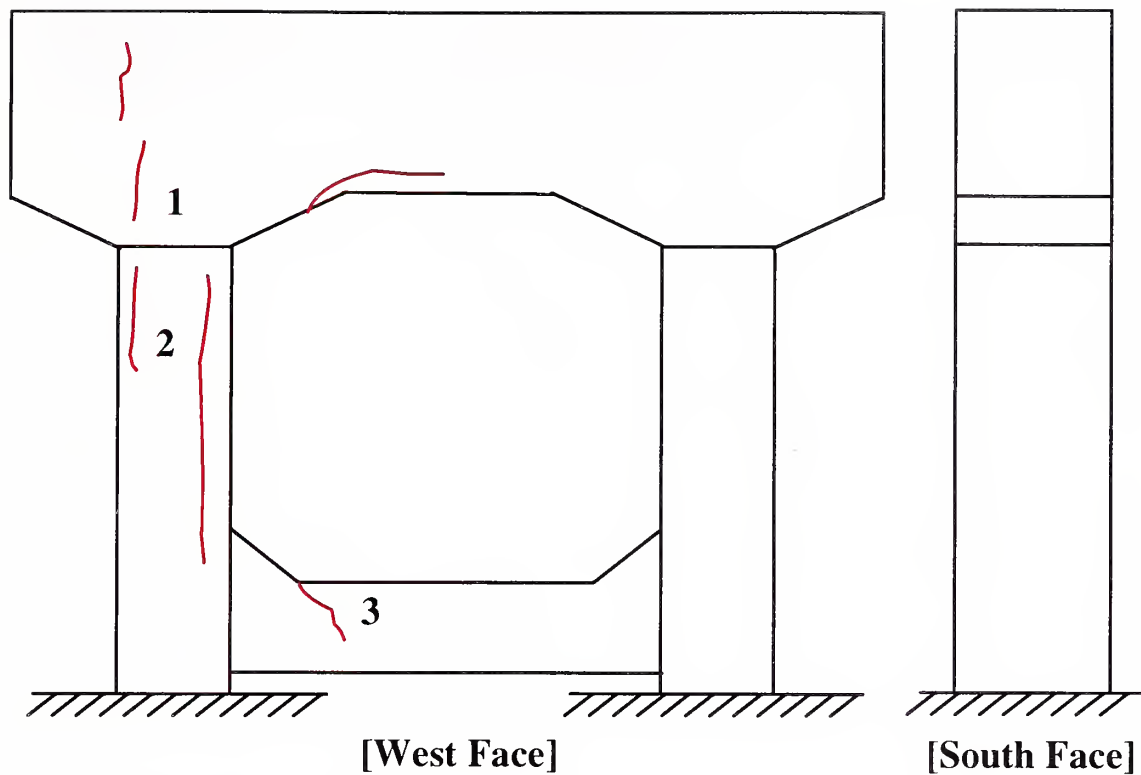
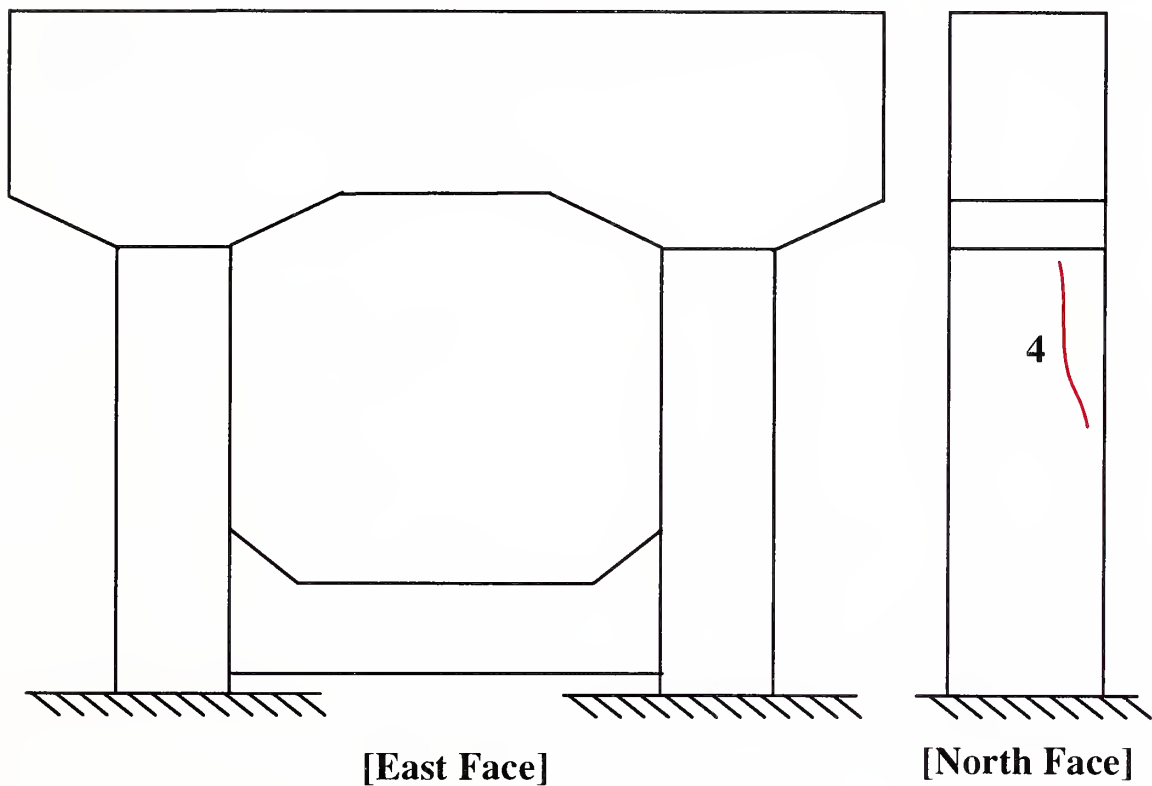
**Figure 40A. Condition of Bent No. 10 (West Bound).**

Damage	Location	Face	Description of Damage (No.)	Leakage Condition: Active leakage below beams 1-2 and moist below beams 2-3, 3-4 Test Performed: None
	Cap	West	Three cracks (1)	
	N. Col.	West	Two cracks (2)	
	Beam	West	A crack (3)	
	N. Col.	North	A crack (4)

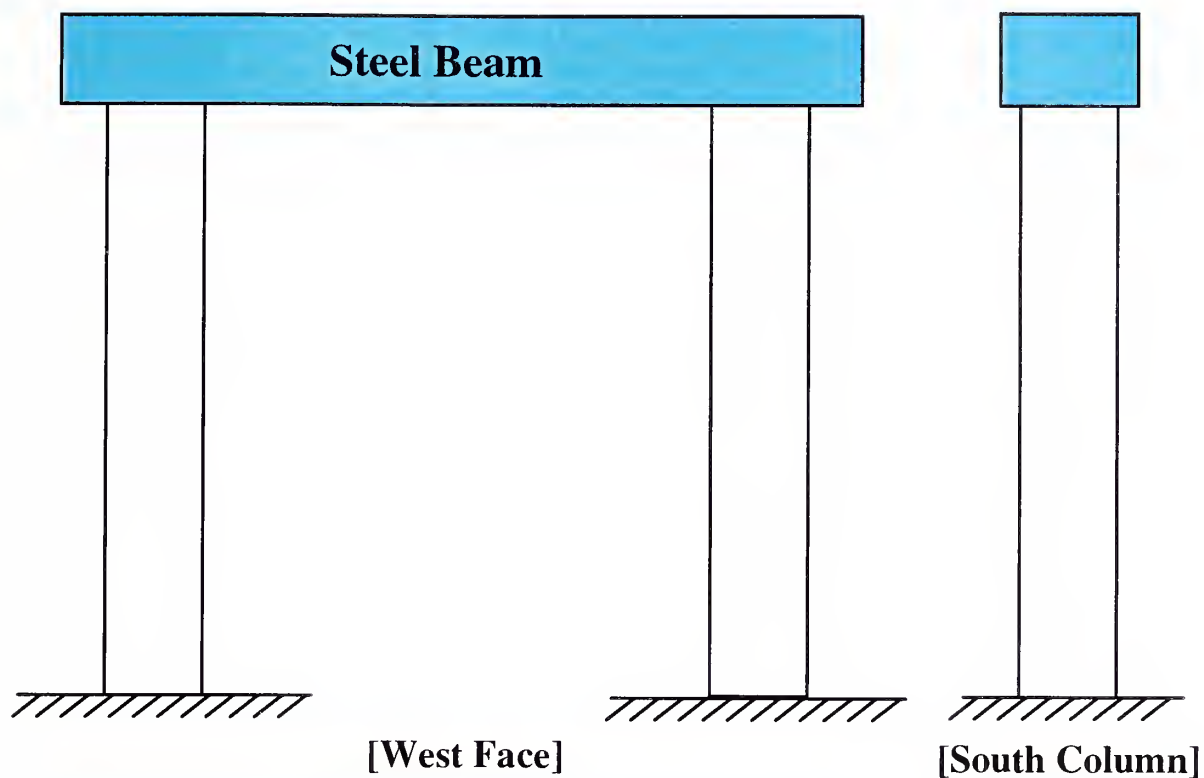
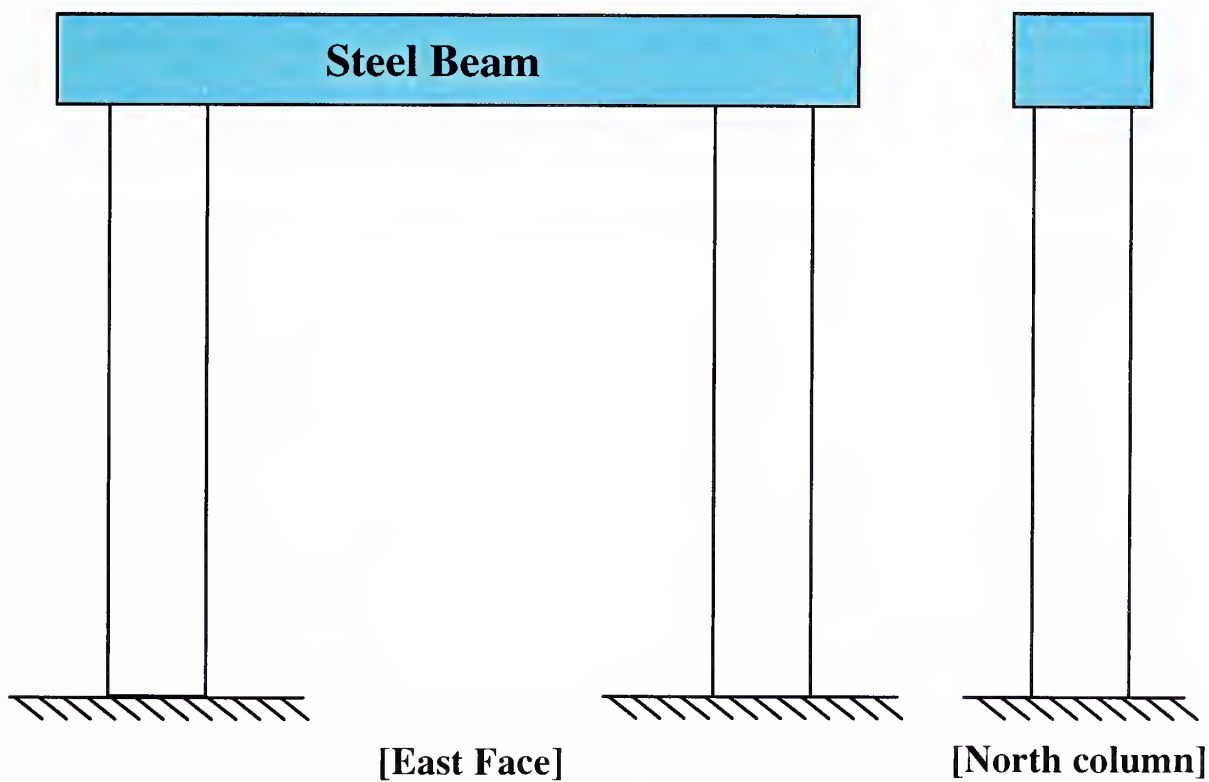
Figure 41A. Condition of Bent No. 11 (West Bound).

Damage	Location	Face	Description of Damage (No.)	Leakage Condition: No deck above and exposed  Test Performed: None
		<b>No Damage Observed</b>
